AFFDL-TR-66-43  
PART X

**AIRCRAFT GROUND-FLOTATION INVESTIGATION**  
**PART X — DATA REPORT ON TEST SECTION 9**

*U. S. ARMY ENGINEER WATERWAYS EXPERIMENT STATION*

**SEPTEMBER 1966**

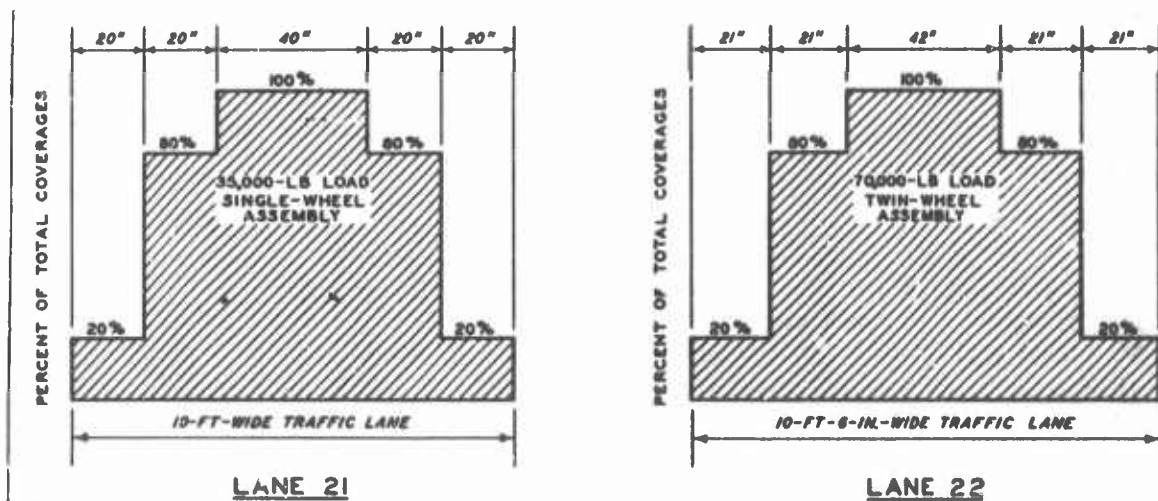
Figure 1. Traffic distribution patterns, Test Section 9

Traffic was applied to the test lanes in a nonuniform pattern with intensity of traffic being varied within each lane to produce three zones of approximately 100, 80, and 20 percent traffic coverage. Traffic so distributed within a traffic lane simulates as nearly as possible the bell-shaped traffic distribution curve which results from the wander of aircraft from the lane center line. The coverage levels referred to in the tables and text herein are the total number of coverages applied to the 100 percent coverage zone. The corresponding number of coverages applied to the outer traffic zones is proportional to the percentage factor for the respective zones as shown in figure 1.

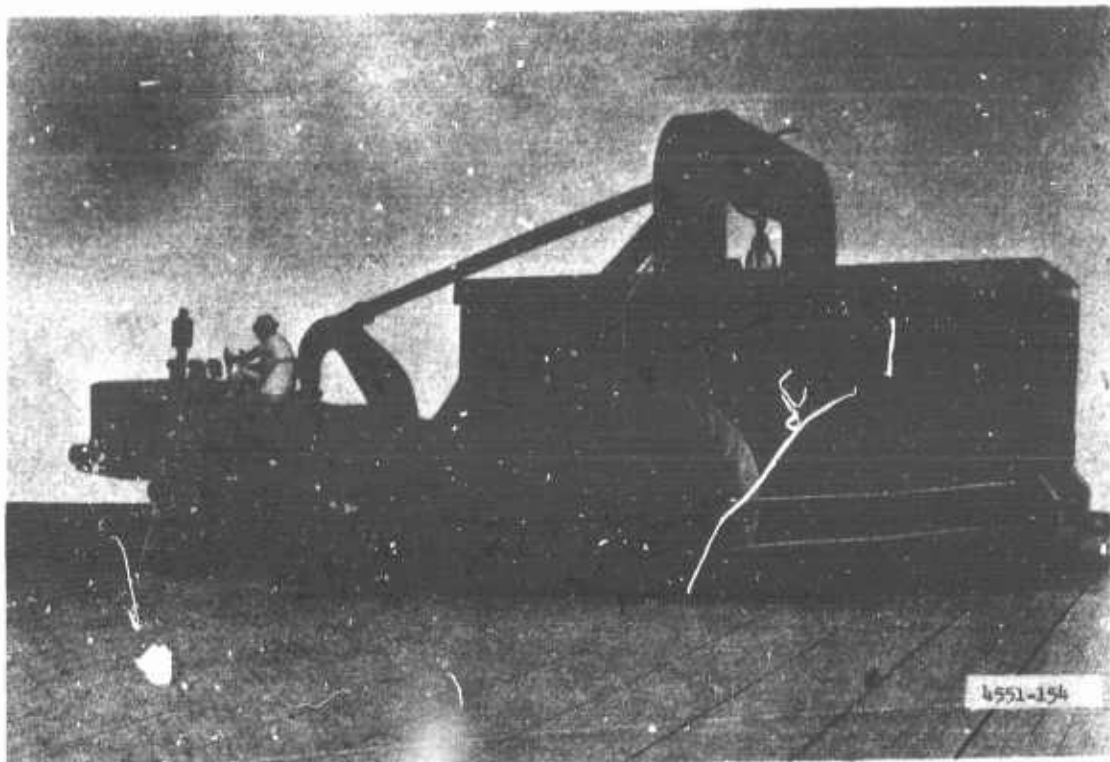
Figure 2. Test load vehicle

The load vehicle is shown in figure 2. Load cart construction, details of linkage between the load compartment and prime mover, and method of applying load are explained in Part I. A 35,000-lb load on a single-wheel assembly and a 70,000-lb load on a twin-wheel assembly were used for trafficking lanes 21 and 22, respectively. Wheel spacing was 42 in. c-c on the twin-wheel assembly. Tires used on both assemblies were 25.00-28, 30 ply with inflation pressure of 50 psi. Tire-print dimensions and tire characteristics are shown in figure 17.

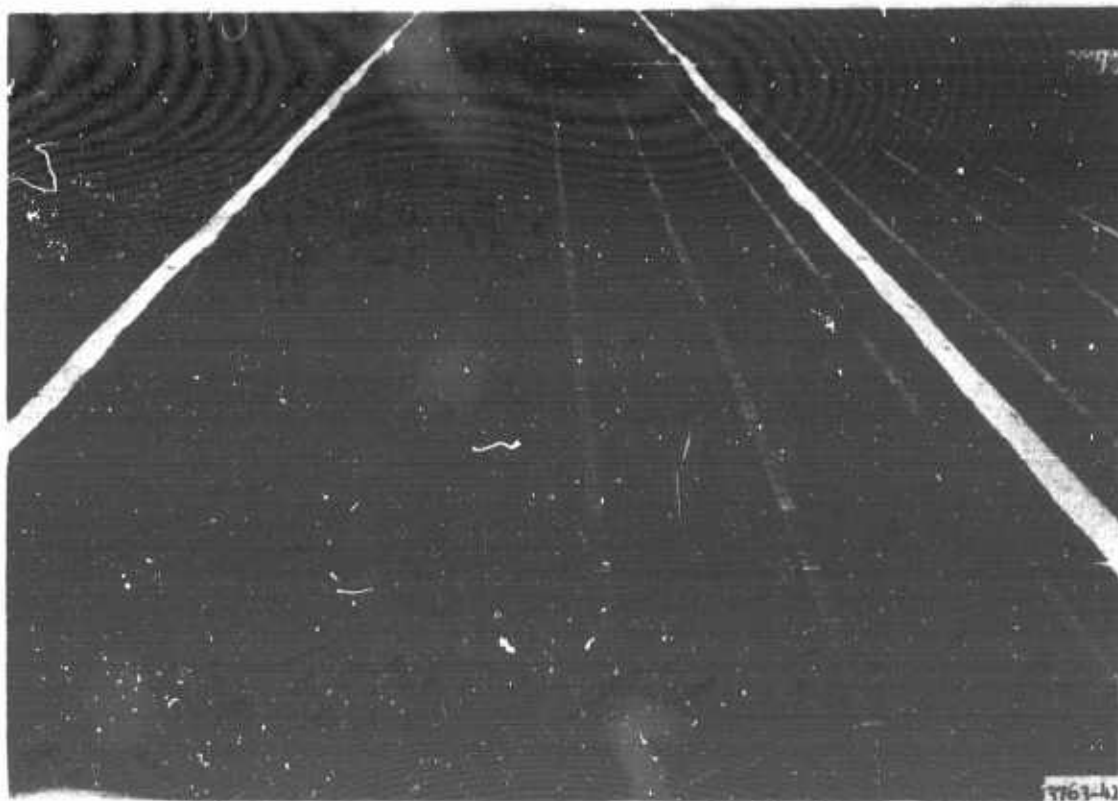
Figure 3. Lane 21, item 1, prior to traffic

Item 1. Figure 3 shows item 1 prior to traffic. The item sustained 600 traffic coverages without developing appreciable roughness or mat breakage. Traffic was suspended at 600 coverages with the item surface remaining in good condition (figure 4). The rated CBR of the item was 1.5.

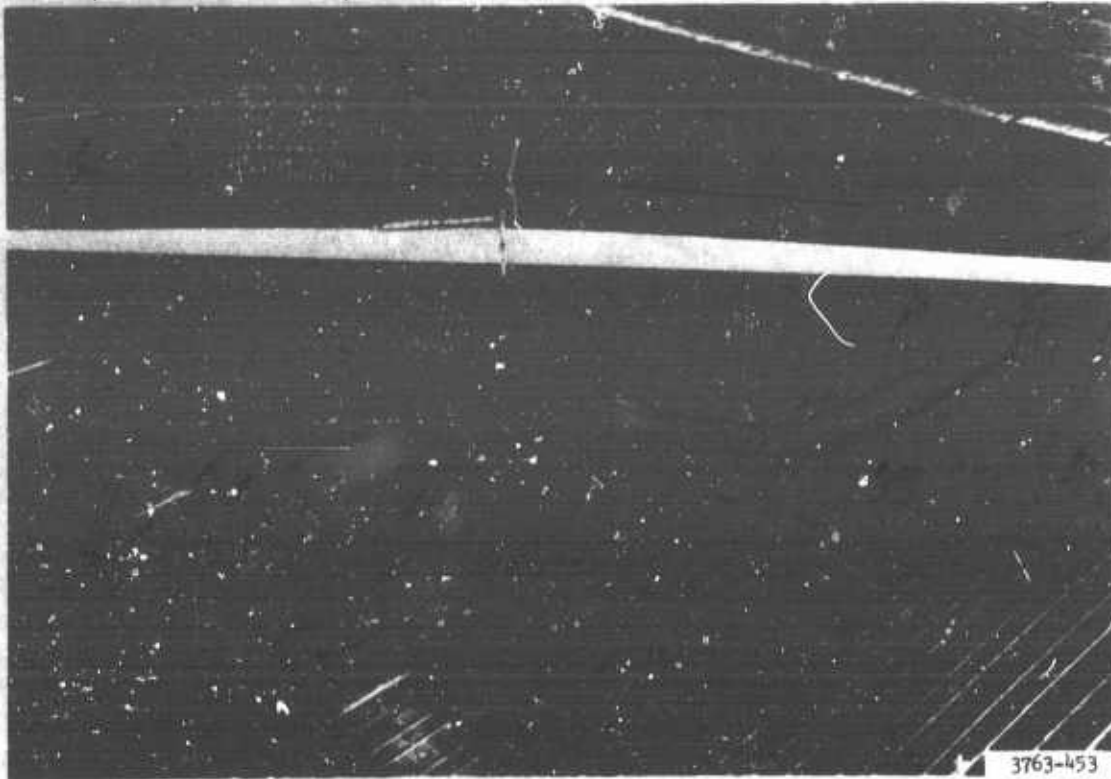
Figure 4. Lane 21, item 1. Diagonal straightedge shows small deformations existing at 600 coverages (traffic suspended)

- a. Roughness. Differential deformations that developed with trafficking are recorded in table 1. At 600 coverages (suspension of traffic), the item was still in good condition with average transverse and diagonal differential deformations of 0.97 and 1.10 in., respectively. Average dishing measurement (table 1) was 0.50 in.

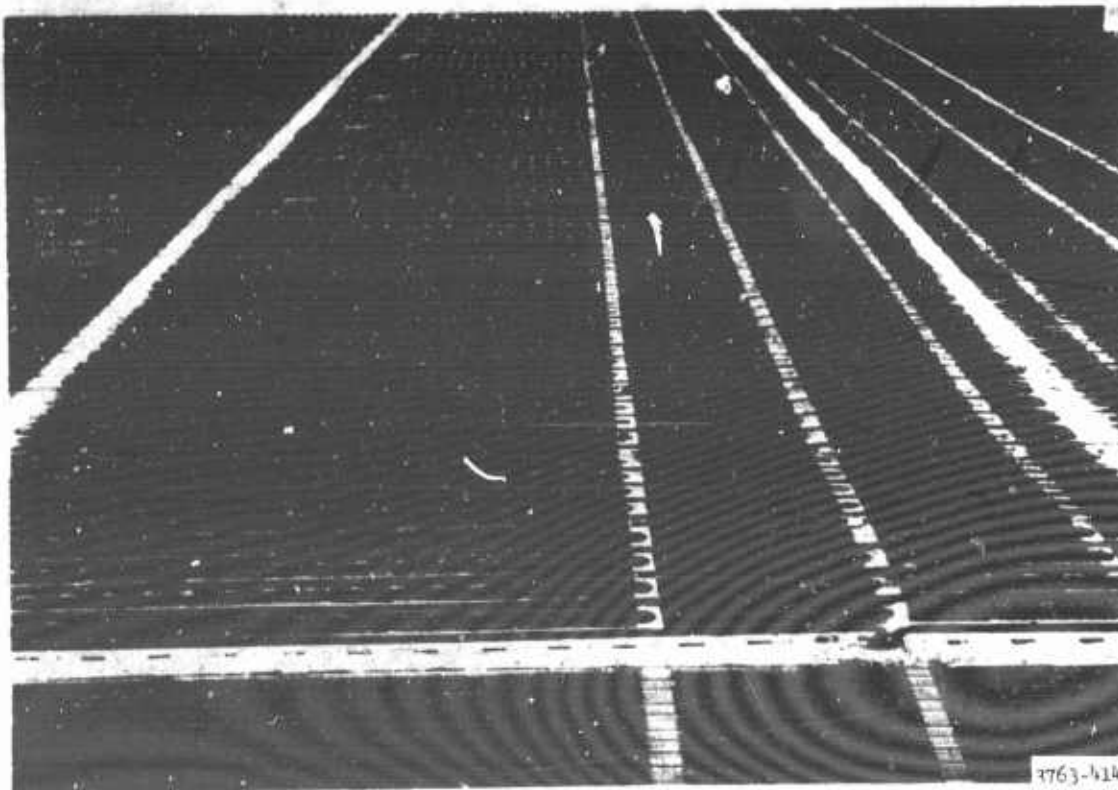
Figure 5. Lane 21, item 2, prior to traffic

Item 2. Figure 5 shows item 2 prior to traffic. At 20 coverages the item evidenced average transverse and diagonal differential deformations of about 1 in. The item held up well under continued trafficking until 300 coverages when it was considered failed due to roughness (figure 6). The rated CBR for the item was 1.9.

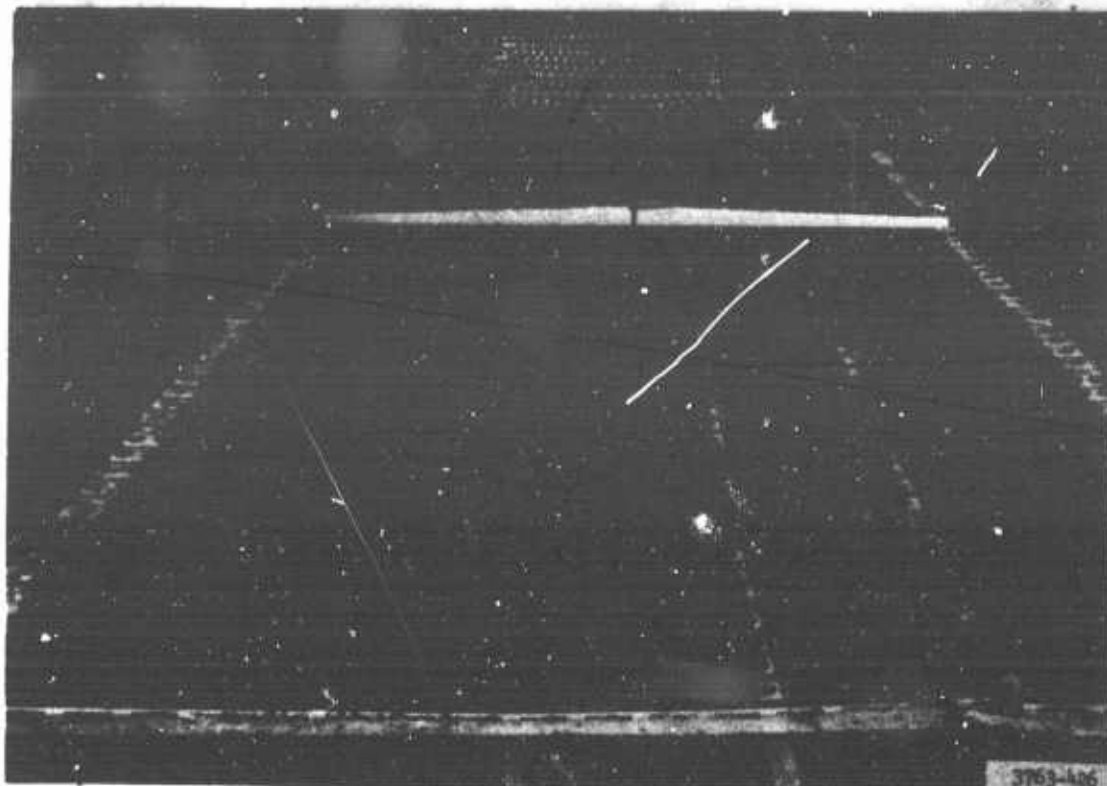
Figure 6. Lane 21, item 2. Transverse straightedge shows roughness at 300 coverages (failure)

- a. Roughness. Differential deformations shown in table 1 indicate a steady increase with number of traffic coverages. At failure the average transverse and diagonal differential deformations were 2.97 and 3.03 in., respectively. Dishing measurements were small, averaging 0.19 in. at failure.

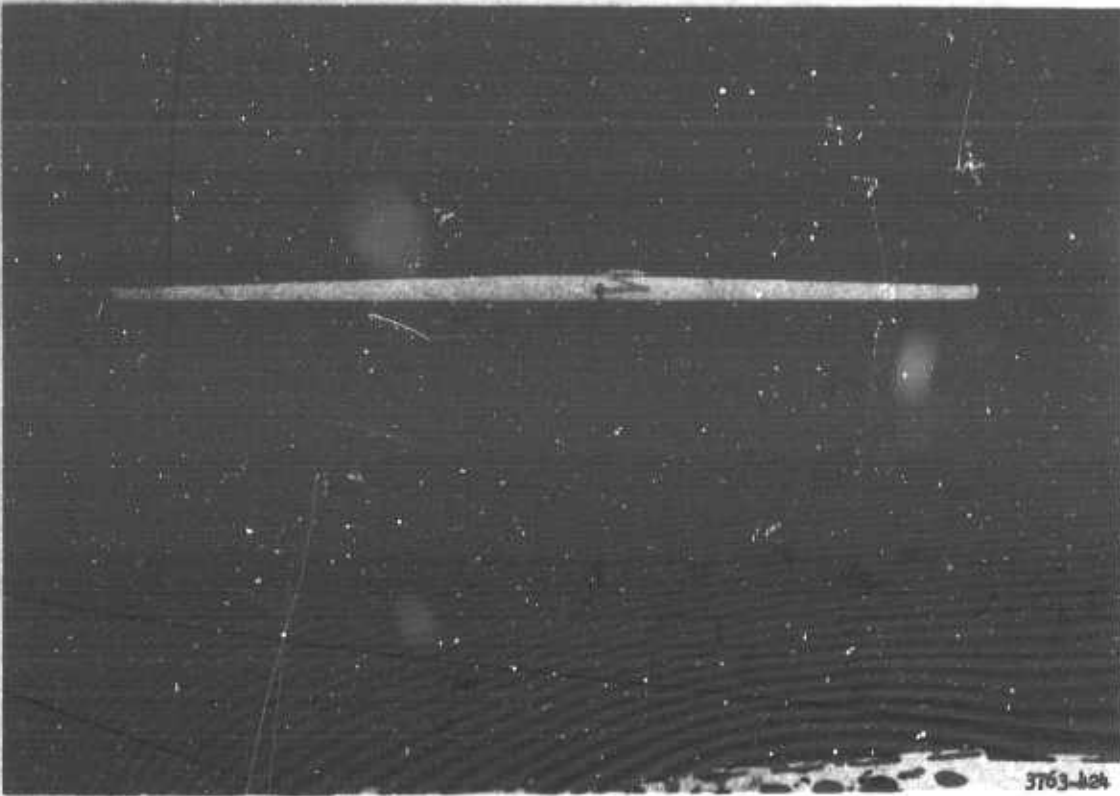
Figure 8. Lane 21, item 3. Transverse straightedge shows roughness at 300 coverages (failure)

Item 3. Figure 7 shows item 3 prior to traffic. The item resisted rutting throughout trafficking. At 300 coverages the item was considered failed due to roughness (figure 8). The rated CBR for the item was 4.7.

- a. Roughness. Differential deformations and rut depths measured at intervals throughout trafficking are shown in table 1. Rut depths did not reach serious proportions at any time, but transverse and diagonal differential deformation showed steady increases with trafficking. At 300 coverages both the transverse and diagonal differential deformations averaged 3.50 in. Average rut depth was 0.91 in.

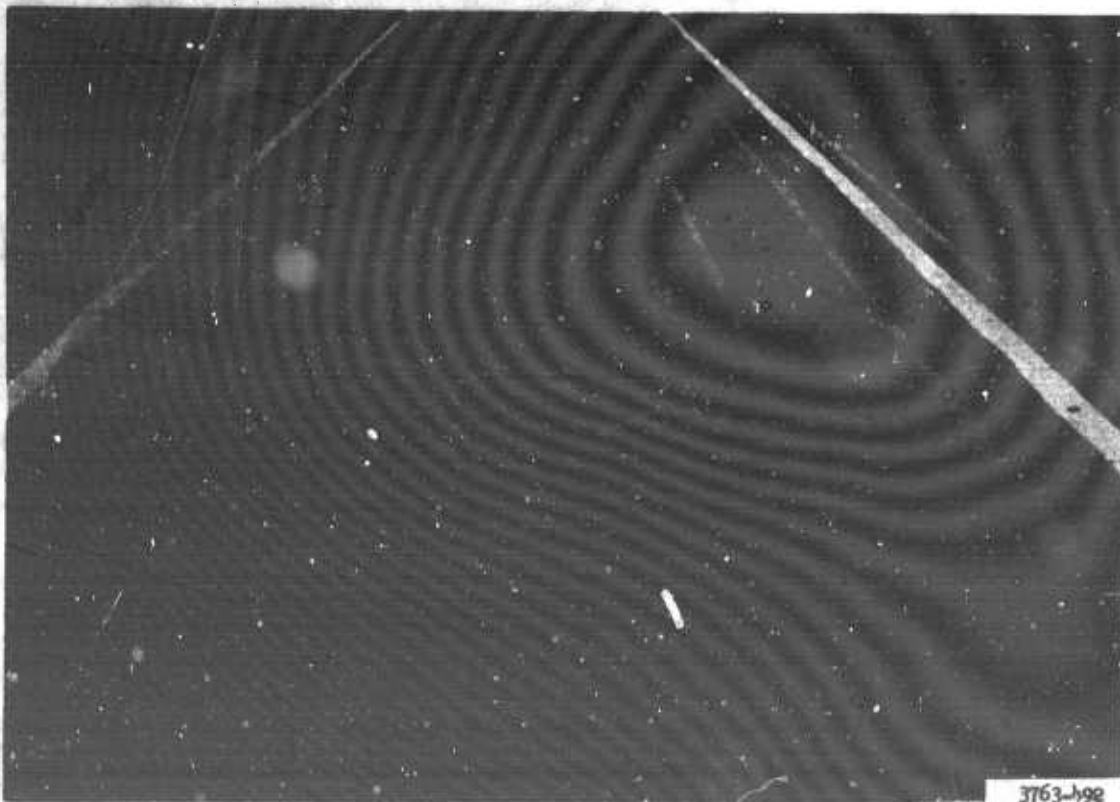
Figure 9. Lane 22, item 1, prior to traffic

Item 1. Figure 9 shows item 1 prior to traffic. The item was considered failed due to roughness at 400 coverages (figure 10). The mat surface was not severely damaged at failure. The rated CBR was 1.8.

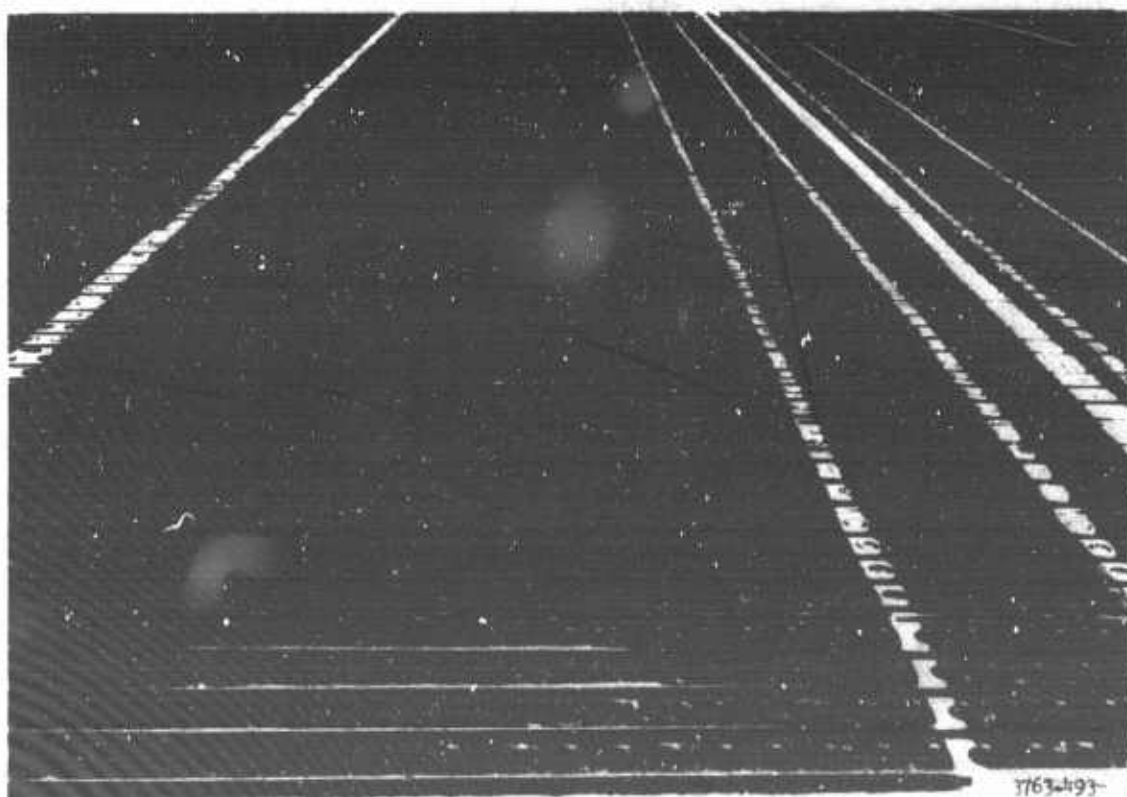
Figure 11. Lane 22, item 2, prior to traffic

Item 2. Figure 11 shows item 2 prior to traffic. The item settled along the center line with trafficking and was considered failed due to roughness at 100 coverages (figure 12). The rated CBR was 1.9.

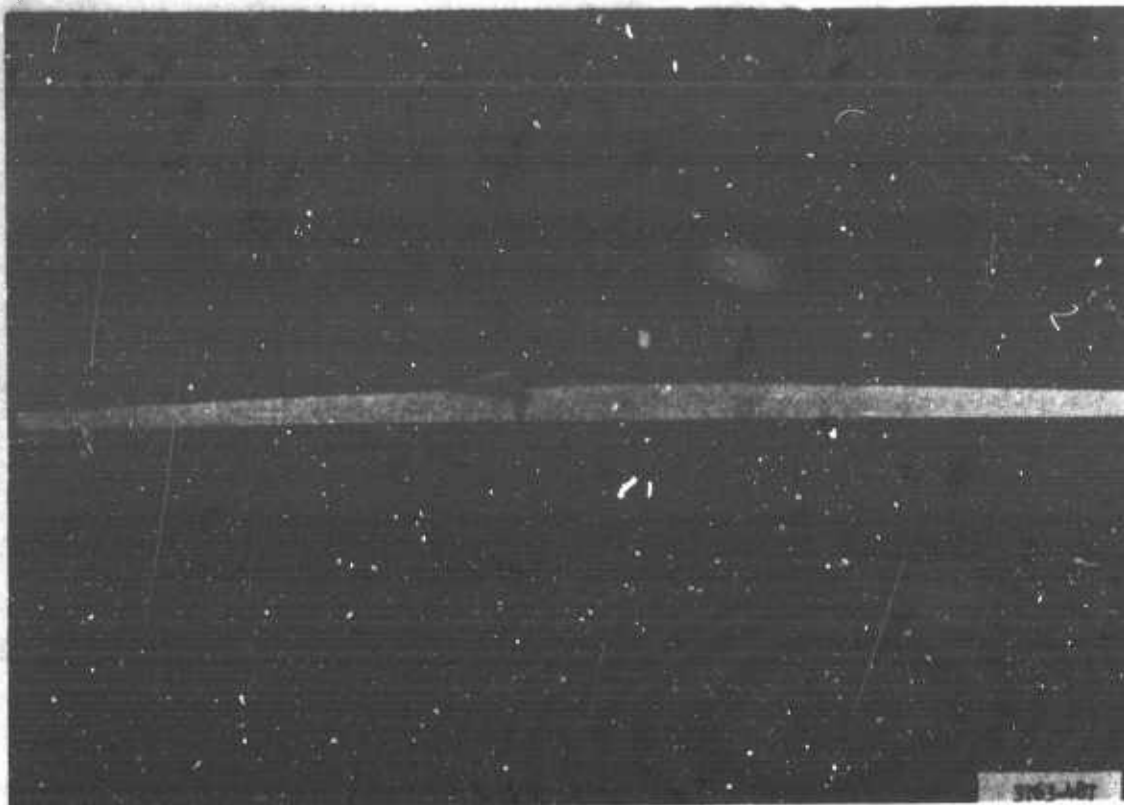
Figure 12. Lane 22, item 2. Transverse straightedge shows roughness at 100 coverages (failure)

- a. Roughness. Differential deformations that developed with trafficking are recorded in table 1. At 100 coverages the average transverse and diagonal differential deformations were 4.19 and 3.88 in., respectively. Dishing of individual mat panels averaged 0.25 in. at 100 coverages.

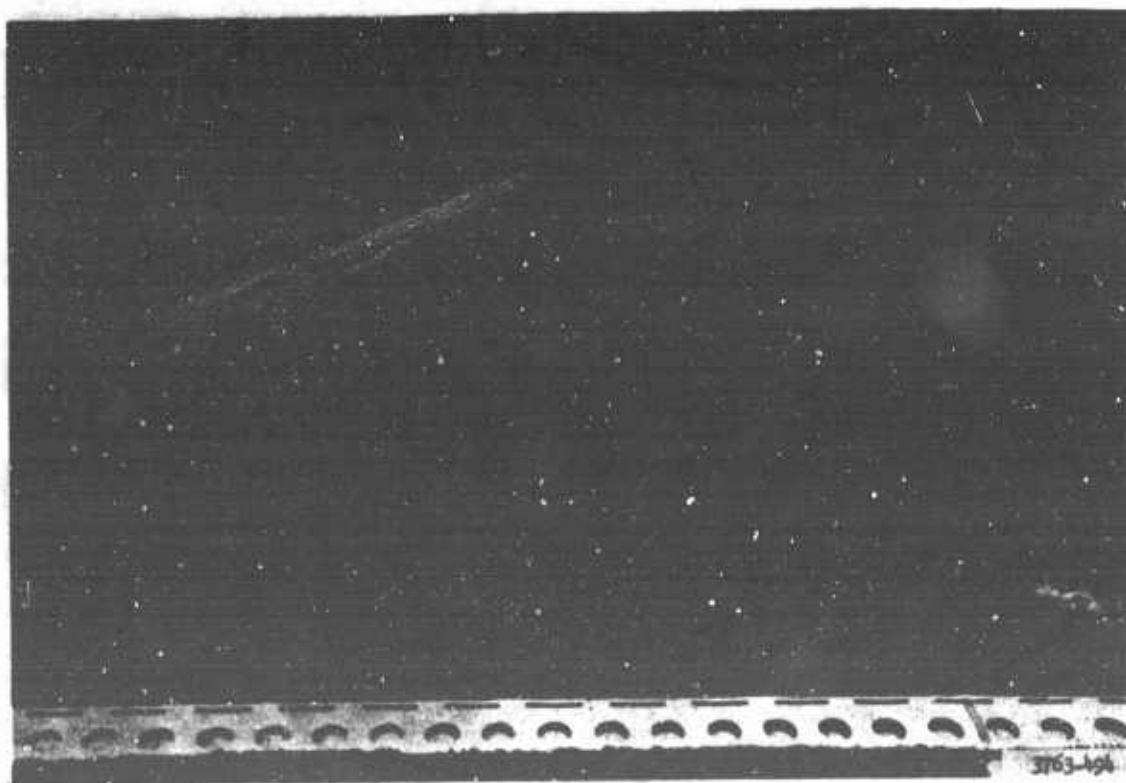
Figure 13. Lane 22, item 3, prior to traffic

Item 3. Figure 13 shows item 3 prior to traffic. The item was considered failed due to roughness at 100 coverages (figure 14). The rated CBR was 4.8.

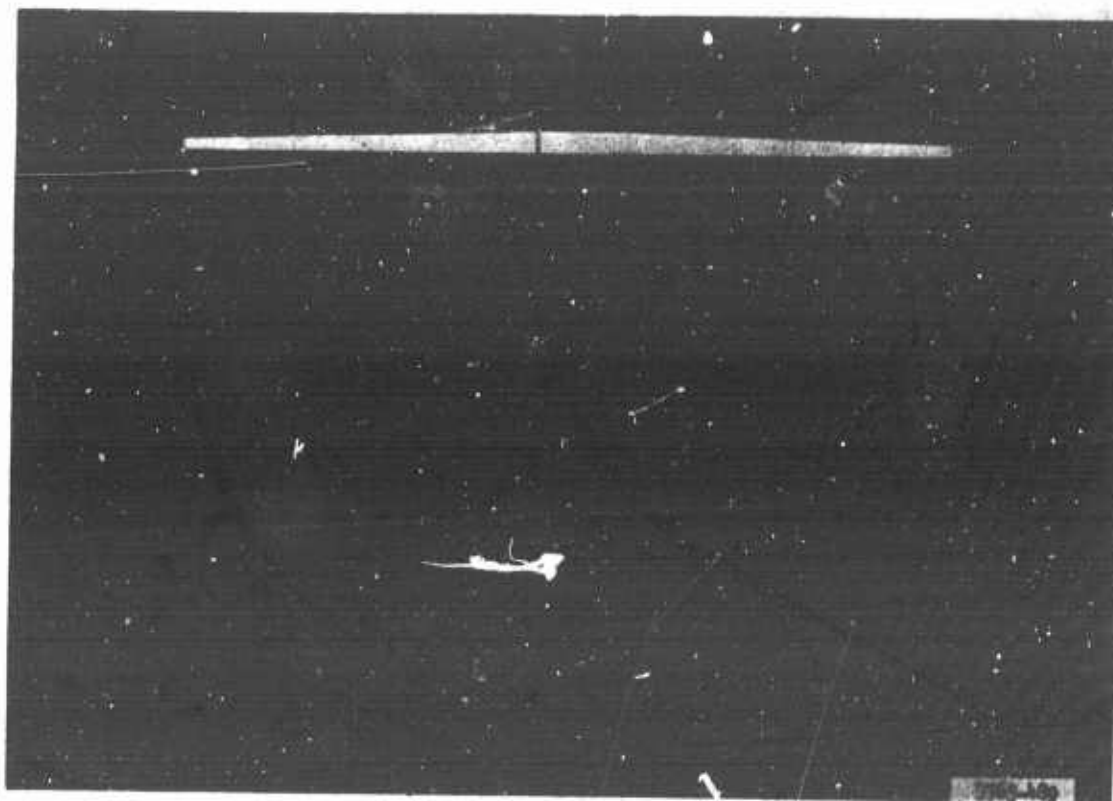
Figure 14. Lane 22, item 3. Transverse straightedge shows roughness at 100 coverages (failure)

- a. Roughness. Differential deformations and rut depths measured at intervals throughout trafficking are shown in table 1. Transverse and diagonal differential deformations were most severe with average readings of 4.07 and 4.10 in., respectively, at 100 coverages. Rut depths averaged 3.62 in. at 100 coverages.

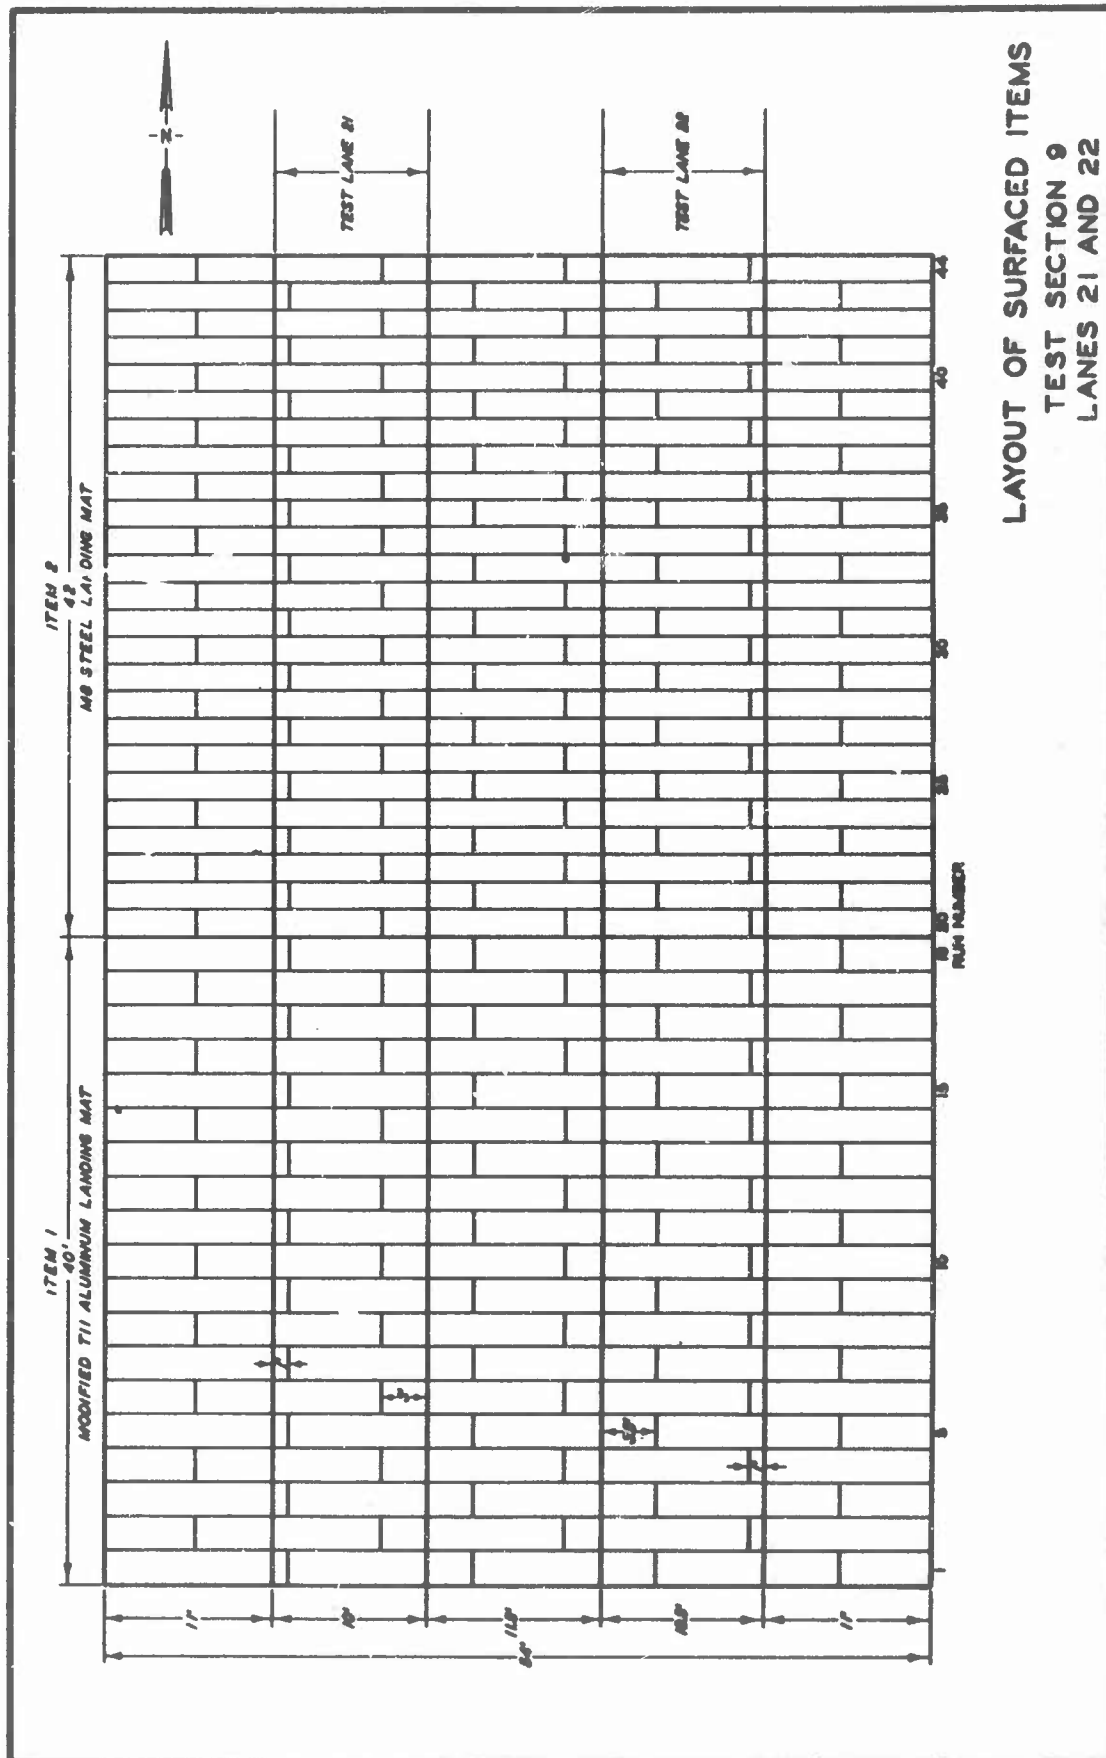
Two traffic lanes divided into three items each were constructed in the test section. Different subgrade strengths were obtained in the items by controlling water content and compaction effort (figure 15). Items 1 and 2 were surfaced with modified T11 aluminum landing mat and M3 steel landing mat, respectively (figure 16), and item 3 remained unsurfaced. The landing mats used are described and illustrated in Part I.
